A novel study for determining early life degradation of multi-crystalline-silicon photovoltaic modules observed in western Himalayan Indian climatic conditions

The results of a first time study are reported on the degradation of a roof mounted multi-crystalline-silicon photovoltaic system after 2.5 years of outdoor exposure in a western Himalayan location in India. The main objective of the study is to identify frequently occurring defects in modules to study the change in electrical performance parameters and correlate these with identified defects under Indian climatic conditions. A comprehensive test campaign is conducted by visual inspection, thermal imaging and current–voltage characteristic measurements. Early degradation and recently reported defect: snail trails are observed in all modules along with non-uniform single cell browning and junction box failure. Thermal imaging analysis is carried out which shows that three modules developed serious defects like hotspots, disconnected cells and string interconnect ribbons and a significant result that all solar cells located directly on top of junction boxes were 3–8 °C hotter than other cells indicating higher thermal degrada

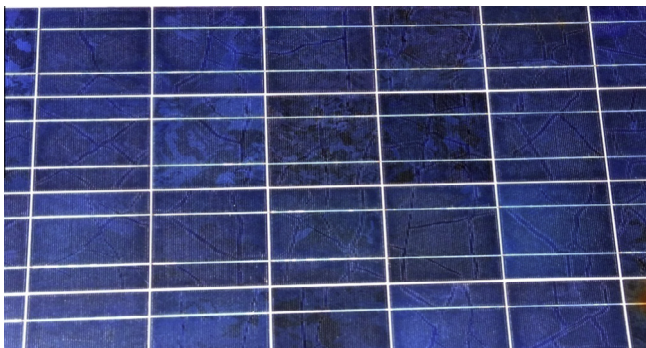
cell cracks. Almost all the modules showed generation of snail tracks which is moving in 50–70% modules area. Snail trails generated in the modules is shown in Fig. 6.

Fig. 6. Snail tracks generated in the modules of 1 kW_p PV array.

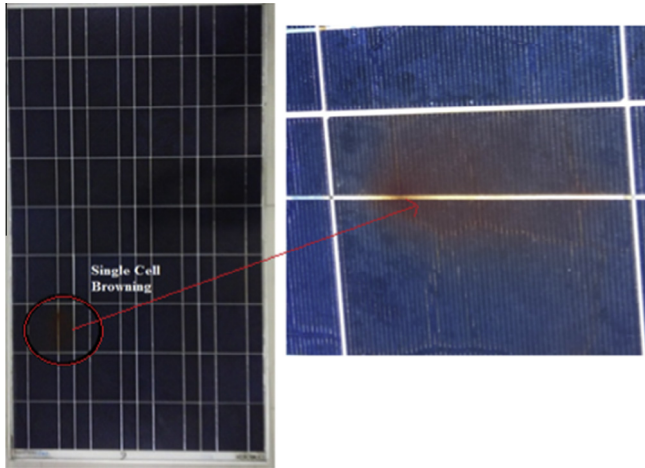
Fig. 7. A single cell showing non uniform browning in PV module no. 6.

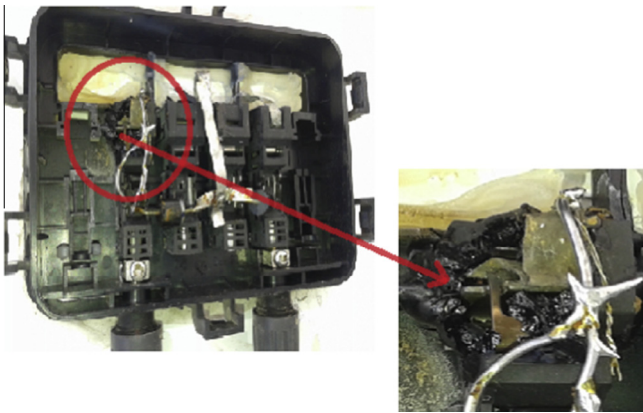
During visual inspection it was observed that the junction boxes of module no. 2 and 10 showed burnt marks outside (Fig. 8). Junction boxes of these two modules were then opened and it was found that the plastic covering over

Fig. 8. Junction box failure in PV modules no. 2 and 10.

the joint (between the terminal in the junction box and terminal from the string interconnect) was burnt and melted.

The cause of burning and melting was due to sparking in the joint between the terminal of the junction box and string interconnect terminal. It was due to poor design of contacts made for joining junction box terminal with the string interconnect terminal. There was no rigid contact made, but rather some sort of plug in the system that too without any screws, leading to free joints.

Bad wiring resulted in internal arcing (burn marks) in the junction box. This failure is particularly dangerous because the arcing can initiate fire. Poor soldering contacts of the string interconnects could cause high resistance and consequent heating in the junction box. In extreme cases the fire danger increases. These bad soldering contacts are caused by low soldering temperature or chemical residuals of the previous production process on the solder joints.

- Failures due to junction box and detachment of terminals are due to the poor quality of supplied modules and are repairable. However, the solution for avoiding these defects is not to use poor quality material, connectors, etc. by the manufacturer.
- The modules (2 and 10) which showed these defects can be repaired to make the modules functional but the issue is to improve the quality of material used by the manufacturer in the first instance to avoid such defects appearing at early stage keeping in view 25 years of guaranteed life of modules.

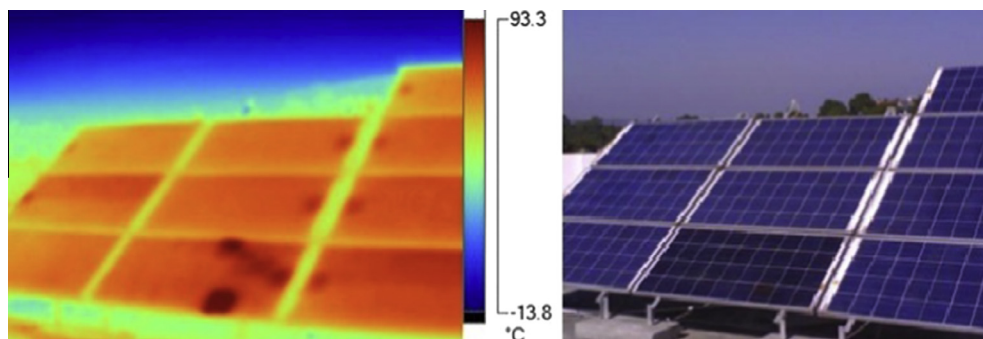
One of the most significant findings from the thermal imaging analysis was the fact that all solar cells lying directly on top of the junction boxes were approximately 3–8 °C hotter than the rest which indicates higher thermal degradation of the cells at these locations could be taking place at higher rates. In order to have more clear view, thermal image of 1 kW_p system is again shown in Fig. 10.

Fig. 9. Infra-red thermal image of roof mounted 1 kW_p PV array.

The module no. 2 and 10 have shown half of the portions at higher temperatures. The junction box failure of module no. 2 and 10 discussed in Section 5.1.3 is again highlighted in the thermal image as half of the portions of these modules are showing higher operating temperatures. The results of the visual inspection and thermal imaging of 1 kW_p m-C-Si array are summarized in Table 4.

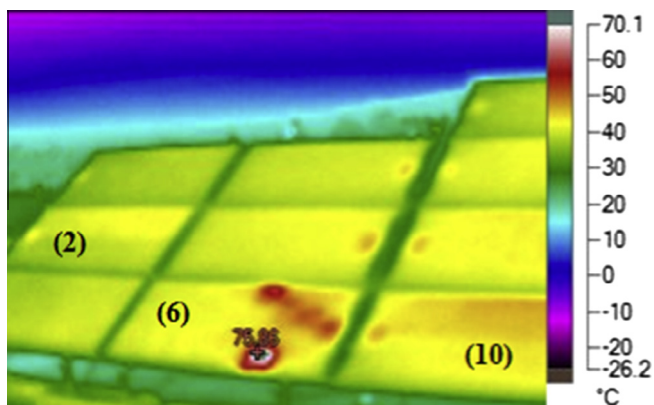
The important finding from Fig. 10 is that module no. 6 clearly shows the hotspots. Conventionally wafer-based c-Si PV modules have number of solar cells, which are interconnected in series with cell interconnect ribbons to obtain higher voltage. These cell interconnect ribbons are connected from the front side to the rear side of the solar cells. A series of interconnected cells is called a string. These cell strings are typically interconnected in series or sometime in parallel by string interconnect ribbons. A weak cell or string interconnect ribbon can result in disconnections. There may be several possible causes of this PV module failure. Poor soldering in the PV module production process of the connection between cell interconnect ribbon and string interconnect is the most important reason for disconnections. A too intense deformation during the fabrication of the ribbon kink between the cells mechanically weakens the cell interconnect ribbon. A narrow distance between the cells promotes cell interconnect ribbon breakage. Physical stress during PV module transportation, thermal cycle, and/or hot spots by partial cell shading during long-term PV system operation forces mechanical

Fig. 10. A disconnected cell interconnections found in the module no. 6.

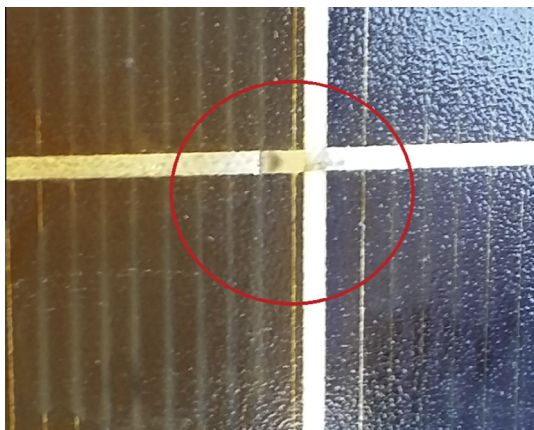
weak ribbon kinks to break. The photograph of disconnected cell interconnect ribbon of module no. 6 near the hot spot area is shown in Fig. 11.

Fig. 11. Image of disconnected cell interconnect ribbon.

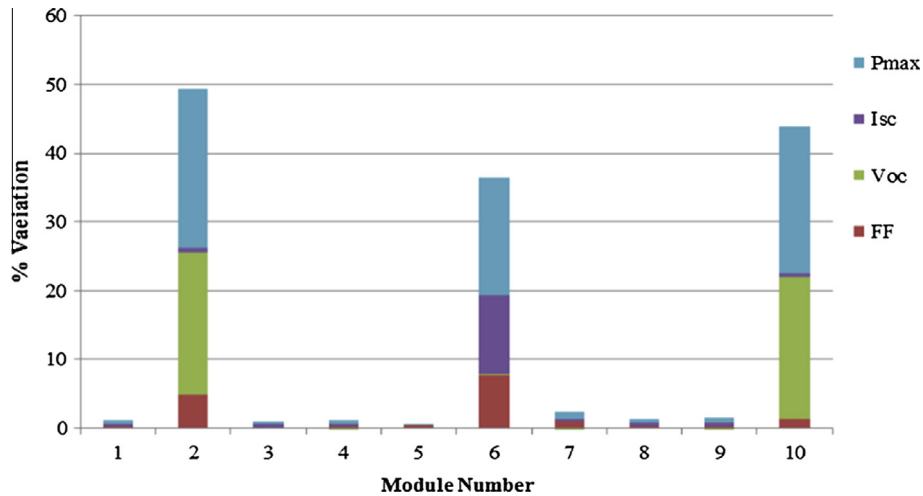
The deviation between the values of characteristic parameters measured initially (reference module 7) and after the outdoor exposure (all the 10 modules) were calculated and plotted in Fig. 12 showing the degradation in each characteristic parameter of the PV modules.

Module no. 2, 6 and 10 have shown 50% average degradation in power in just 2.5 years of outdoor exposure while the remaining modules showed reasonable degradation in their peak power between 0.6% and 2.5% in 2.5 years. A comparison of I–V curves of module no. 2, 6 and 10 with the I–V curve of reference module measured under STC is shown in Fig. 13.

Fig. 12. Percentage variation in characteristic parameters of modules.

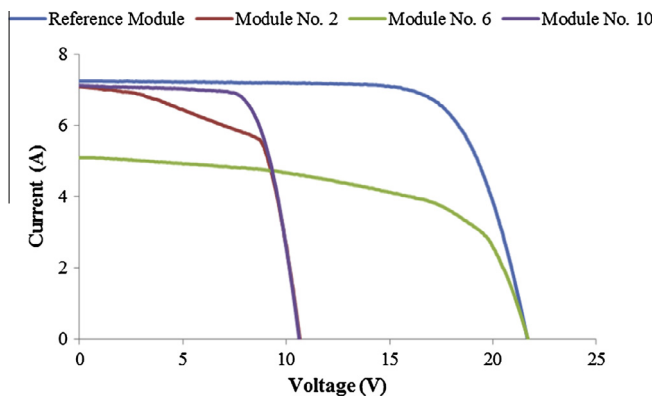
Fig. 13. I–V curve comparison of degraded modules (no. 2, 6 and 10) with the reference module (module no. 7).

The degradation of power in module no. 2 and 10 is clearly visible because of the degradation in their V_{oc} values, while degradation in the power of module no. 6 is due to reduction in the I_{sc} and FF. The module no. 6 is the one which has hotspots. It is important to note that module no. 2 and 10 are those which have shown the temperature gradient as shown in Fig. 9. The degradation in V_{oc} values is attributed to the fact that half of the series

connected strings of solar cells in these modules got disconnected because of the junction box failure. The contact between the terminal in the junction box and terminal from the string interconnect through bypass diode of both the modules (2 and 10) were damaged due to this by pass diodes were not able to perform the normal function. This is due to poor quality control and soldering practices during the manufacturing process which require to be improved.

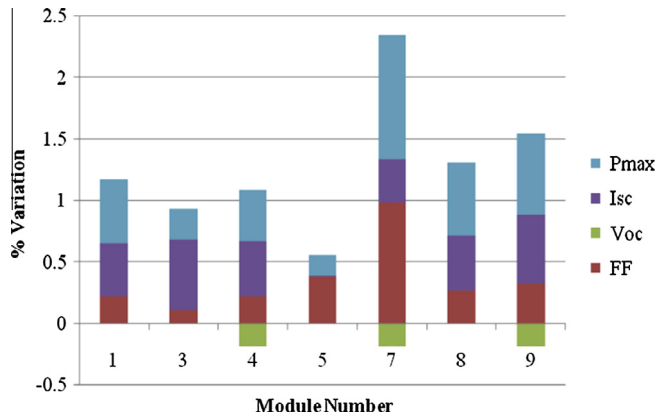
The remaining modules of the array are also showing reasonable degradation in their characteristic parameters as shown in Fig. 15.

P_{max} degradation was found to be between 0.6% and 2.5% in just 2.5 years with an average degradation rate of 0.51% per year. The results show that three modules (no. 2, 6 and 10) have shown 50% average degradation in power in just 2.5 years of outdoor exposure while the remaining modules showed reasonable degradation of around 0.51% per year.

Fig. 15. Percentage variation in characteristic parameters of remaining modules excluding most degraded modules (no. 2, 6 and 10).
