A novel study for determining early life degradation of multi-crystalline-silicon photovoltaic modules observed in western Himalayan Indian climatic conditions

The results of a first time study are reported on the degradation of a roof mounted multi-crystalline-silicon photovoltaic system after 2.5 years of outdoor exposure in a western Himalayan location in India. The main objective of the study is to identify frequently occurring defects in modules to study the change in electrical performance parameters and correlate these with identified defects under Indian climatic conditions. A comprehensive test campaign is conducted by visual inspection, thermal imaging and current–voltage characteristic measurements. Early degradation and recently reported defect: snail trails are observed in all modules along with non-uniform single cell browning and junction box failure. Thermal imaging analysis is carried out which shows that three modules developed serious defects like hotspots, disconnected cells and string interconnect ribbons and a significant result that all solar cells located directly on top of junction boxes were 3–8 °C hotter than other cells indicating higher thermal degrada

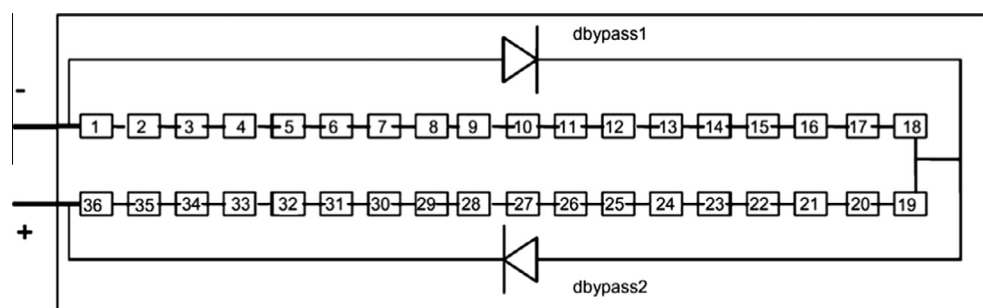
Fig. 14. Configuration of bypass diodes used in the junction box of each PV module.

The two bypass diodes are used in the junction box of each module. The configuration of bypass diodes in the module is shown in Fig. 14.
